Low-flow remedies

This guide is to help the homeowner or installing contractor correct a problem with restricted flow rate through GROHE Europlus, Eurowing, Ladylux Plus, and Ladylux Café kitchen faucets.

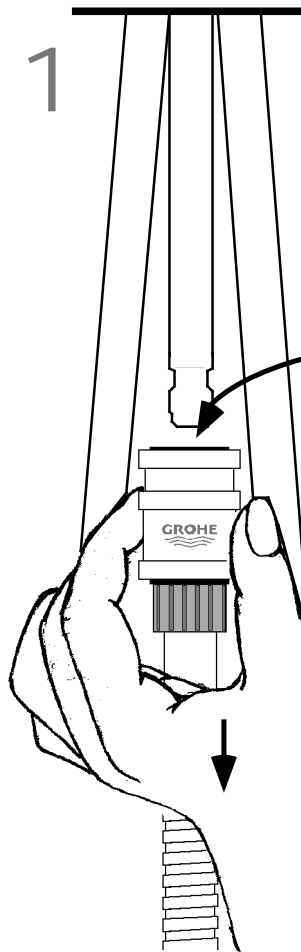
clear the quick coupling

Look under the sink and locate the yellow & black quick coupling. Pull-down on the yellow ring, and the quick coupling will detach from the mixed water supply tube.

Tap or rinse out the debris from the top of the coupling.

The quick coupling can be easily unscrewed from the hose if needed.

When the coupling is clean, screw it back on to the hose. Hand tighten only!

To re-attach, slide the yellow ring back, and press the coupling onto the tube. Test the connection by pulling lightly down on the hose.

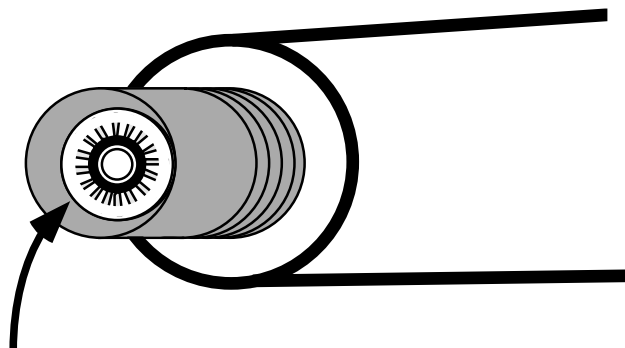
clean the spray head restrictor

Unscrew the spray-head from the hose, and look into the connection end of the spray-head

Inside of the connection piece, there is a flow-restrictor that can get filled with fine sand or dirt. Rinse out the dirt. If the black rubber o-ring is removed for cleaning, it must be replaced to meet California flow requirements.
