GROHE

Low-flow remedies

This guide is to help the homeowner or installing contractor correct a problem with restricted flow rate through GROHE Europlus, Eurowing, Ladylux Plus, and Ladylux Café kitchen faucets.

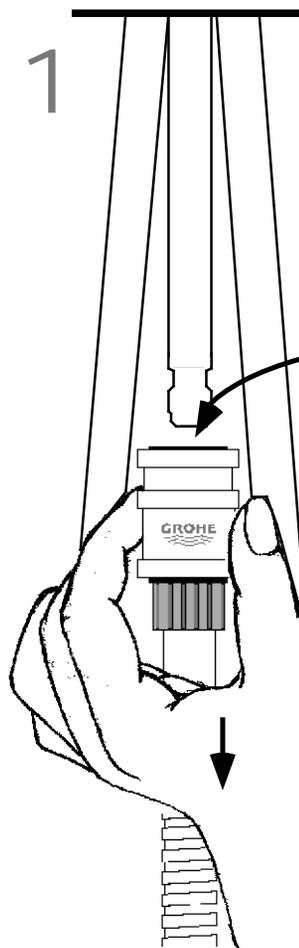
1

Look under the sink and locate the yellow & black quick coupling. Pull-down on the yellow ring, and the quick coupling will detach from the mixed water supply tube.

Tap or rinse out the debris from the top of the coupling.

The quick coupling can be easily unscrewed from the hose if needed.

When the coupling is clean, screw it back on to the hose. Hand tighten only!

To re-attach, slide the yellow ring back, and press the coupling onto the tube. Test the connection by pulling lightly down on the hose.

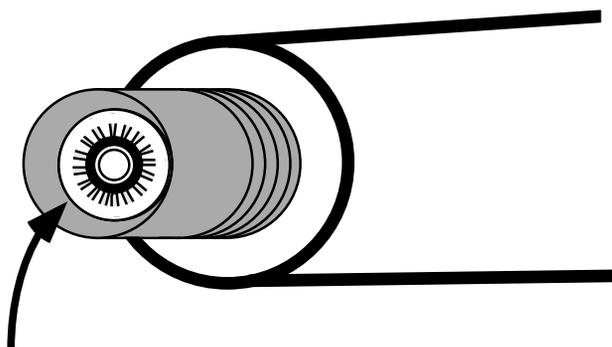
2

Unscrew the spray-head from the hose, and look into the connection end of the spray-head

Inside of the connection piece, there is a flow-restrictor that can get filled with fine sand or dirt. Rinse out the dirt. If the black rubber o-ring is removed for cleaning, it must be replaced to meet California flow requirements.
